FIELD NOTES • AI-CAD BENCHMARK

# Where AI-CAD breaks.

We handed an AI CAD agent two real, scanned fiberglass hoods and one rule: **log every miss**. It modeled them, checked its own work against the scan, and wrote down everything it got wrong, including the misses its checks only just caught. These are the notes.

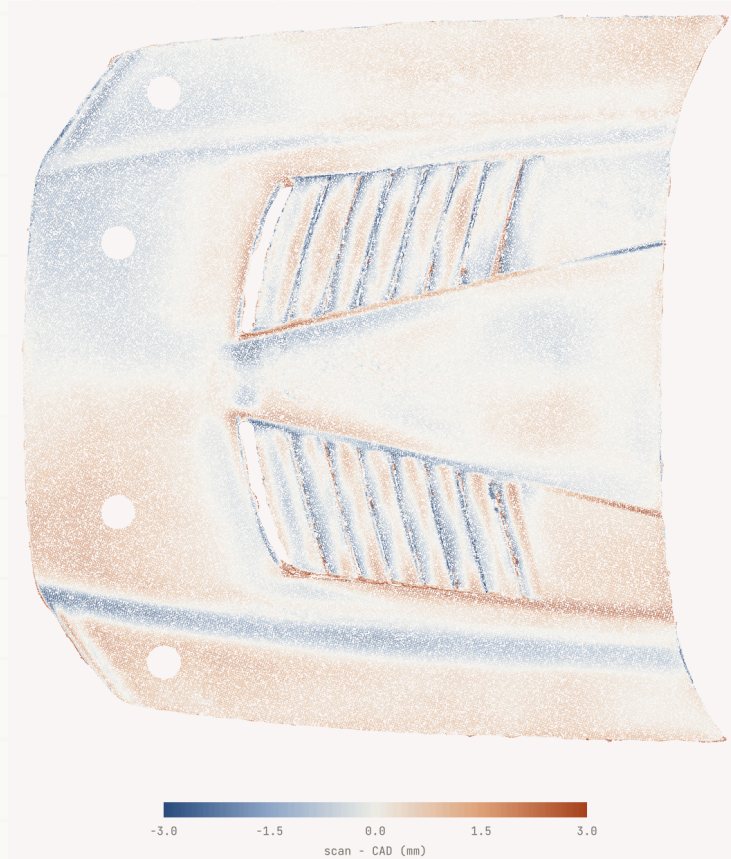
**GROUND TRUTH** Signed deviation, scan to AI-built CAD. Every claim in these notes is measured against a physical part.
